Citroën C3 Aircross
Standard Safety Equipment

2017

Tested Model	Citroën C3 Aircross Feel Puretech 82, LHD
Body Type	- 5 door MPV
Year Of Publication	2017
Kerb Weight	1126kg
VIN From Which Rating Applies	- all C3 Aircross
Class	Small MPV

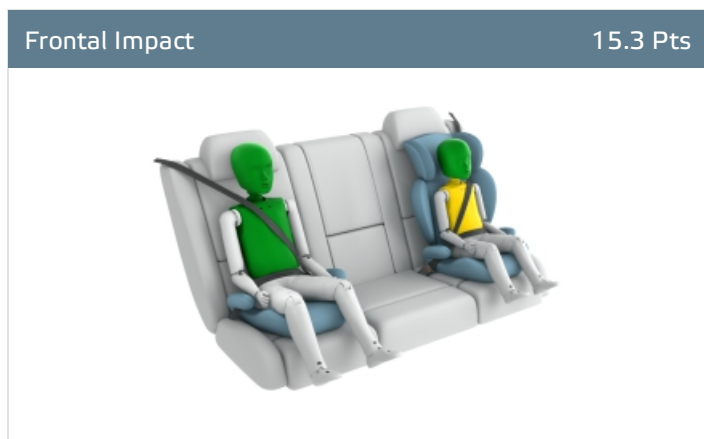
Crash Test Performance based on 6 & 10 year old children

23.3 Pts

In the frontal offset test, protection of both the 6 and 10 year dummies was good or adequate. In the side barrier test, protection was good for all critical body areas. The front passenger airbag can be disabled to allow a rearward-facing child restraint to be used in that seating position. Clear information is provided to the driver regarding the status of the airbag and the system was rewarded. Universal restraints which use the adult seatbelt should not be used in the rear centre seating position but, otherwise, restraints could be properly installed and accommodated.
